# FRANKLIN AID

Franklin Application/Installation Data *Europe*

No. 1/2014

Based on frequently asked questions from the field, today's issue of Franklin AID will again cover the topic "upthrust operation".

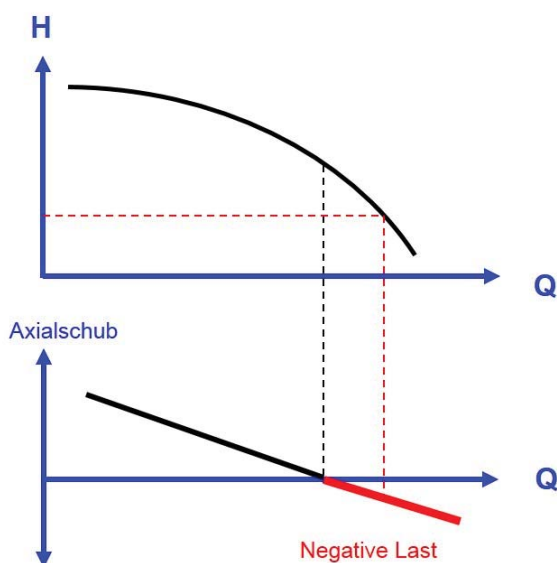
If a pump delivers more water than specified (see curve below), the impellers (depending on type of pump) will not apply further pressure, instead they will move up together with the pump shaft (Figure 1).

Figure 1:  
Negative axial thrust load

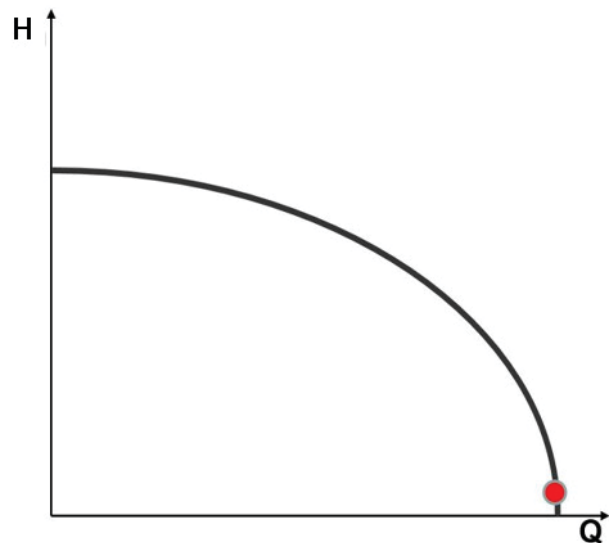
In the curve below, the operating point of the pump is very far to the right (Figure 2).

Figure 2:  
Operating point of the pump at end of the curve

In a correctly installed application, this will only happen once when the pump is first taken into service and the riser pipe is filled. During further operation the pipe remains filled with water by properly installed check valves in the line or by the non-return valve in the pump.

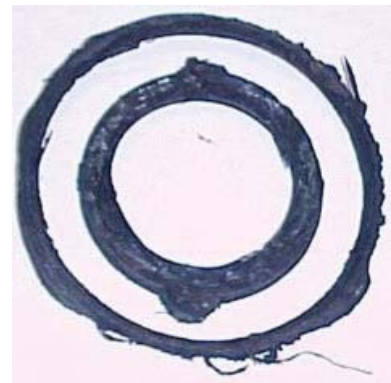
Due to the friction-locked connection between pump coupling and motor shaft the upward movement of the pump shaft is also transferred to the rotor of the submersible motor. This may result in the rubbing of the upthrust washer.

Submersible motors can handle this upthrust for a limited time. Permanent upthrust operation will lead to the destruction of the upthrust washer as the constructional limits are exceeded.

Figure 5:  
Destroyed upthrust washer

This can cause damage on both, the motor and the pump. In the event of damage, both components, motor as well as the pump, should be checked.

The abrasion of the upthrust washer will impair the lubrication of the radial and thrust bearings and can lead to damage.

An upthrust damage always indicates a system related cause.

In a properly carried out installation especially regarding non-return valves, an upthrust of the pump during start-up is limited to a minimum or even to zero.
