Doc. No.: 308 018 677 Rev.:0

Installation manual SACRIFICIAL ANODE KIT P/N: 308 250 914 for FRANKLIN ELECTRIC 4" NG SUBMERSIBLE MOTORS

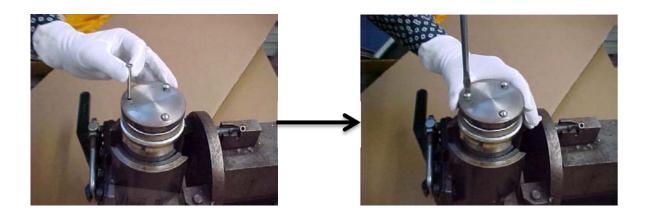
2. Assemble anode with supplied screws one at a time. Tighten securely with 2,2 Nm torque.

Not replacing the screws one at a time may cause the bottom end bell to loosen and potentially damage its components.

1. Remove one screw and washer at a time from the bottom end bell cover of the Motor.

To prevent fluid loss during screw removal, care must be taken to keep end bell assembled to stator at all times. Execute work while motor is positioned upside down, but NOT resting on the shaft.
