# FRANKLIN AID

Franklin Application/Installation Data *Europe*

No. 1/2014

Based on frequently asked questions from the field, today's issue of Franklin AID will again cover the topic "upthrust operation".

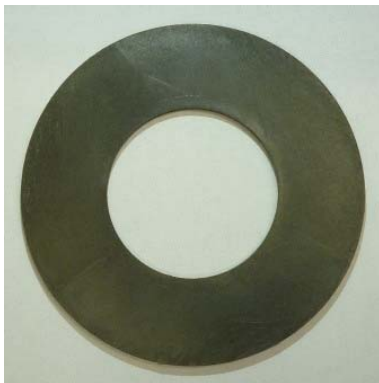
Figure 3:  
New upthrust washer

Due to the friction-locked connection between pump coupling and motor shaft the upward movement of the pump shaft is also transferred to the rotor of the submersible motor. This may result in the rubbing of the upthrust washer.

Submersible motors can handle this upthrust for a limited time. Permanent upthrust operation will lead to the destruction of the upthrust washer as the constructional limits are exceeded.
